NHS Breast Screening Programme Equipment Report

Practical evaluation of Hologic 3Dimensions digital mammography system in 2D mode

December 2019

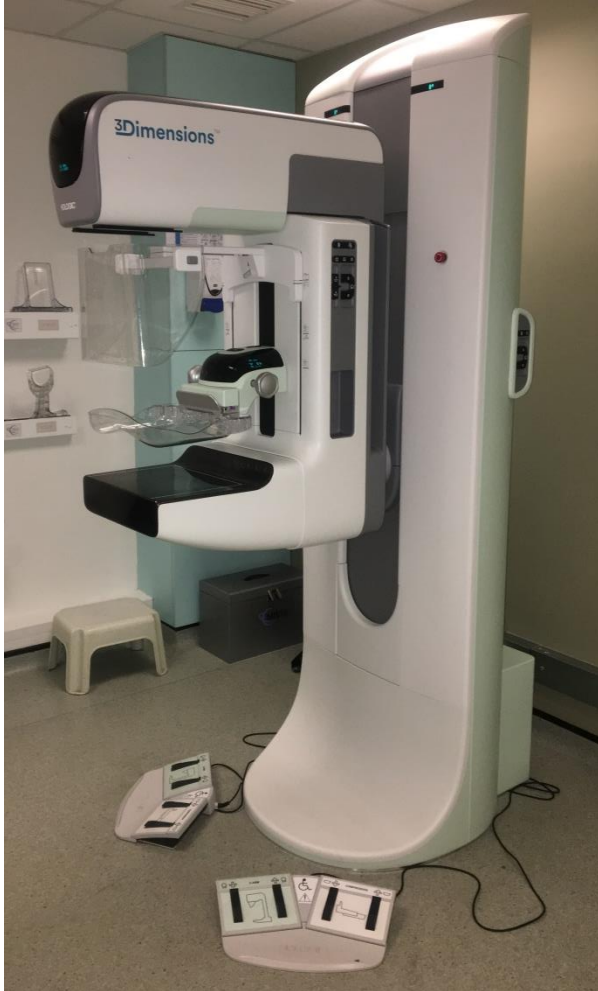
The acquisition workstation (AWS) has a single 3MP monitor fixed on a console with ergonomic features of adjustable height and biometric login. The AWS can be set up to adjust the height automatically to suit the individual operator.

It has a keyboard and a separate touchscreen control pad with a mouse. There is a lead glass radiation shield attached to the console. In addition to the footswitch for exposure, there is also a single exposure button at the AWS.

Figure 1. Hologic 3Dimensions X-ray set

In the first few weeks, the touchscreen was found to be too sensitive, leading to occasional inadvertent selection of the wrong name. The problem was resolved by having an engineer to reduce the sensitivity.

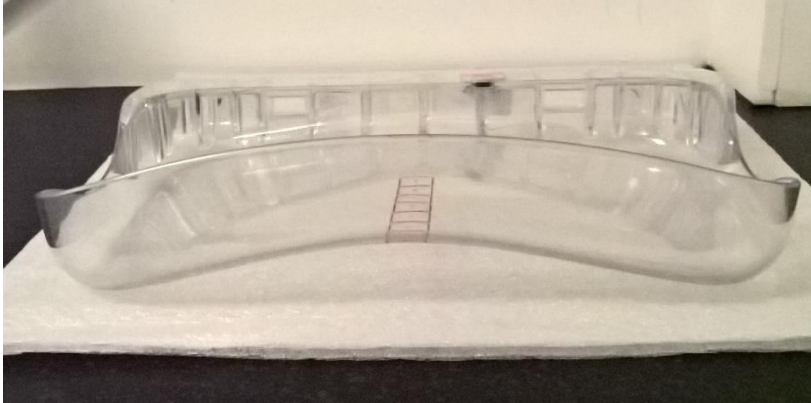
18cm x 24cm and 24cm x 29cm SmartCurve paddles were in general use as well as the flat paddles. Figure 2 shows a 24cm x 29cm SmartCurve paddle. The shape of the 18cm x 24cm is similar.

Figure 2. SmartCurve paddle, 24cm x 29cm version

The difficulties often experienced with breasts less than 50mm thick were as follows. Many found that extending the breast forward in the CC view, and holding it there whilst compression was applied, caused their hands or wrists to be trapped by the lower part of the SmartCurve paddles. With the MLO views, supporting the breast fully until compression was sufficient to hold the breast and demonstrate the inframammary angle (IMA), could also result in their wrists or hands becoming trapped. Alternatively, they found that the inframammary fold was compromised, as they had to let go of the breast to get their hand out.

Some users reported difficulty in positioning with the SmartCurve paddle, as their hand became trapped under the outer curved edge. This was more likely to occur with smaller breasts. It was reported that the paddle caused some discomfort at the axilla for a few women; this may depend on the body habitus. It would be best to avoid using the SmartCurve paddle for certain cases, such as very small breasts.

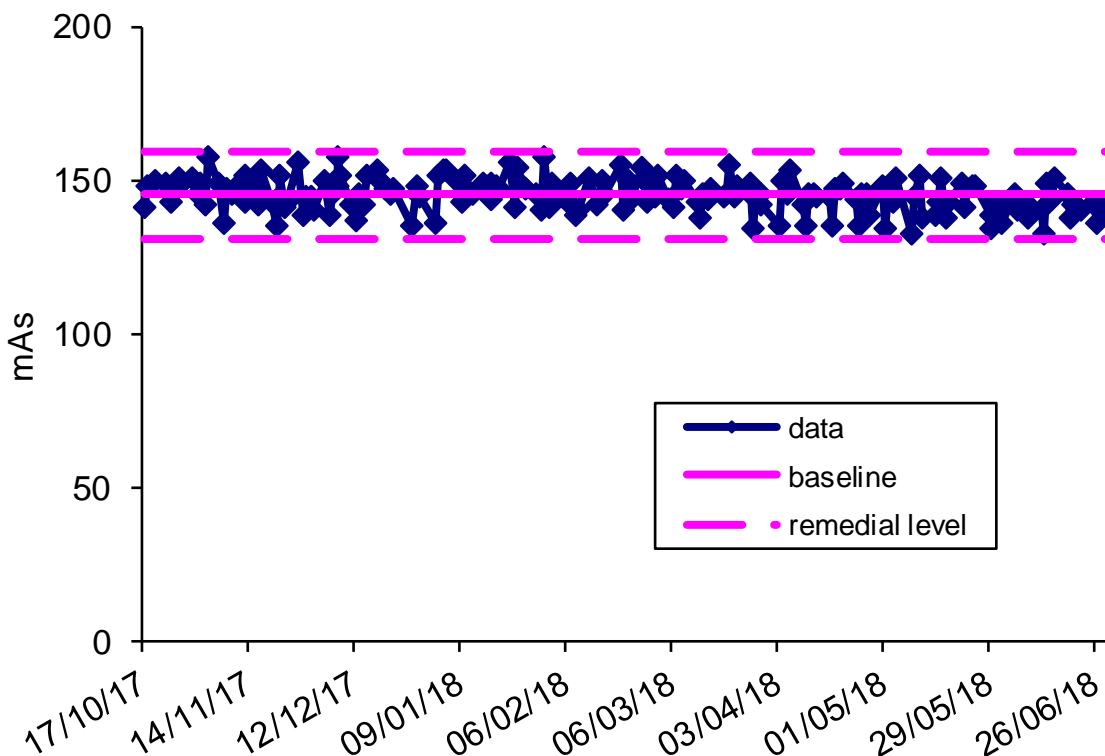
Figure 3. mAs recorded daily for 45mm of Perspex

The results are presented in Figures 3 to 6. Measurements of CNR are only required weekly, but as the measurements were recorded daily, daily CNR is shown in Figure 6.

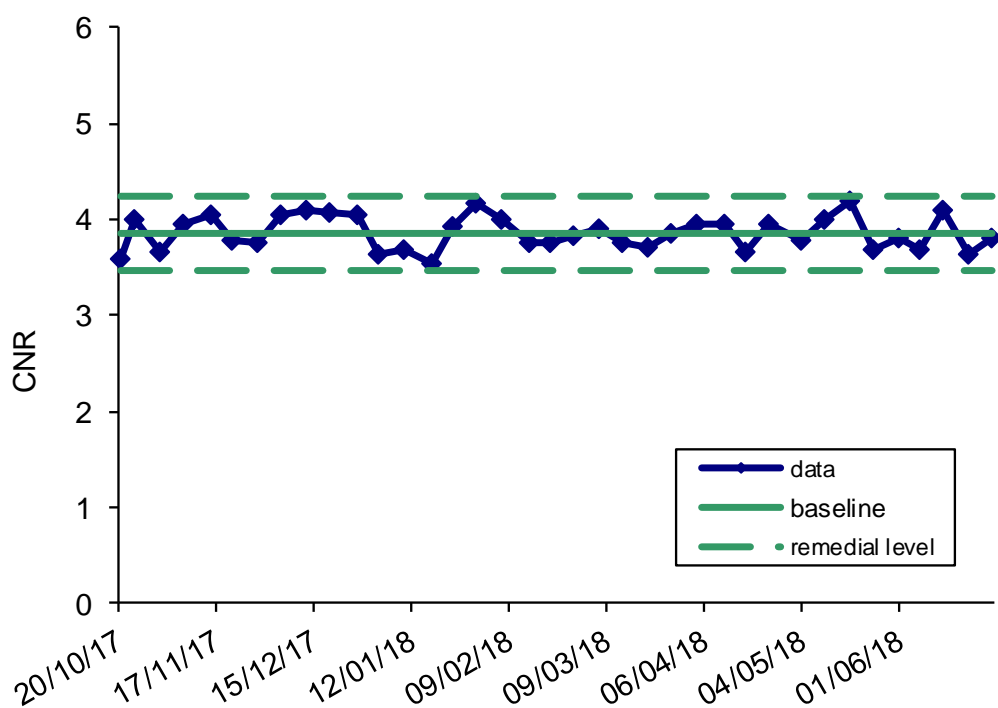
Figure 7. CNR recorded weekly for 45mm of Perspex

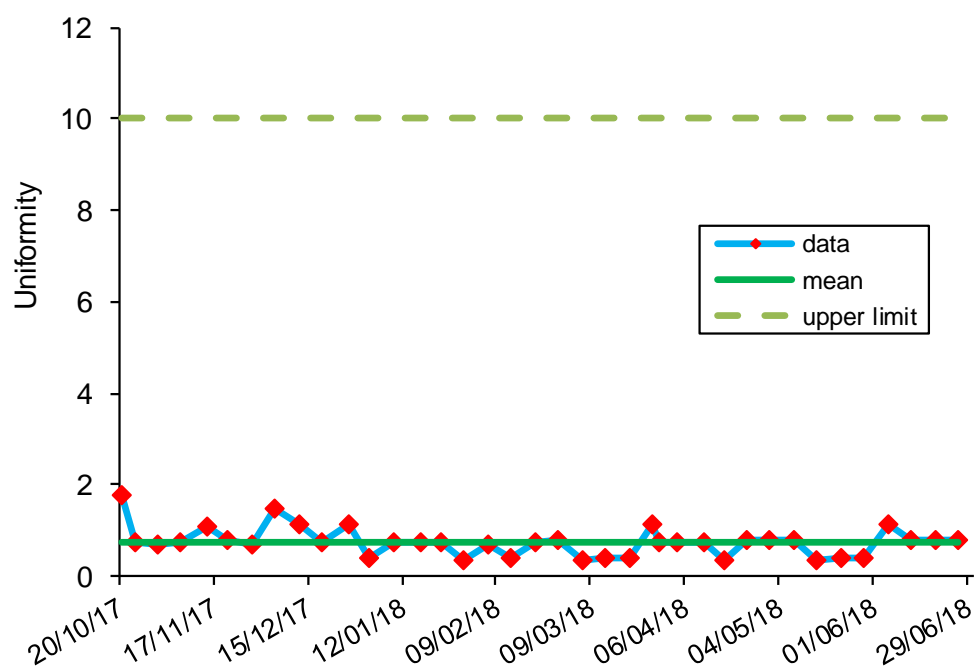
Figure 8. Uniformity measured weekly with 45mm of Perspex

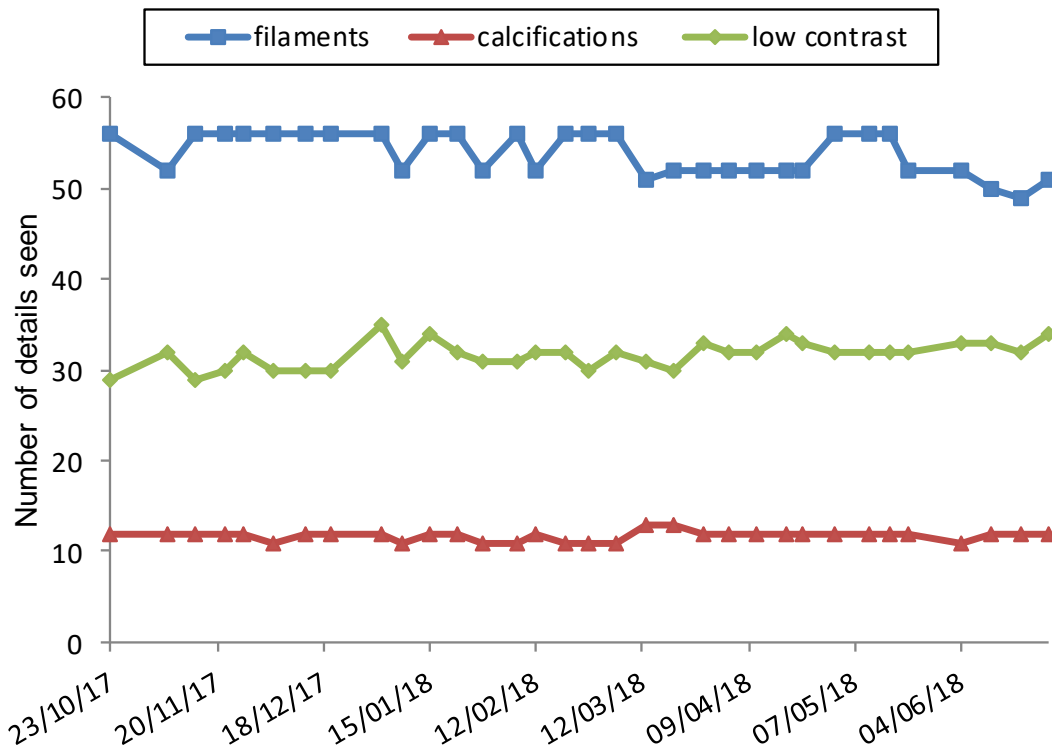
Figure 9. Image quality measured weekly with TORMAM test object

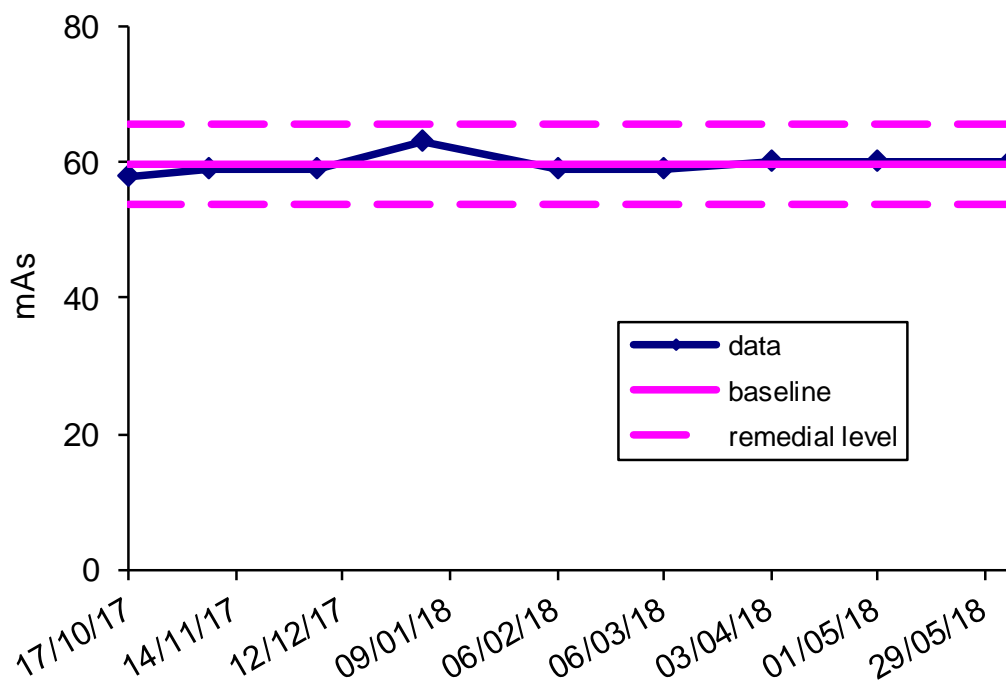
Figure 10. mAs recorded monthly for 20mm of Perspex

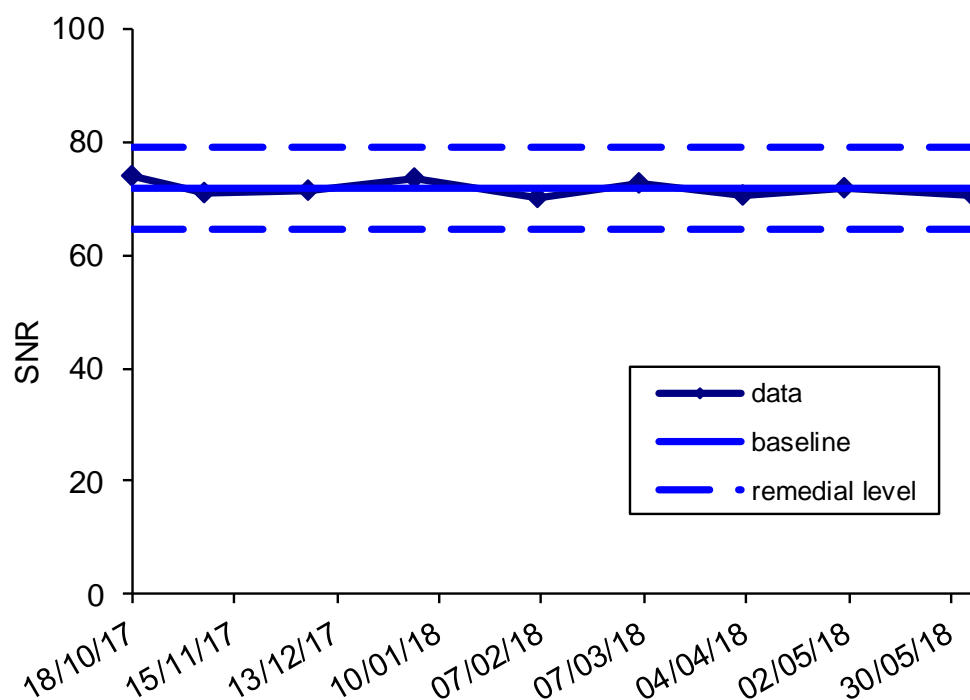
Figure 13. SNR recorded monthly for 70mm of Perspex

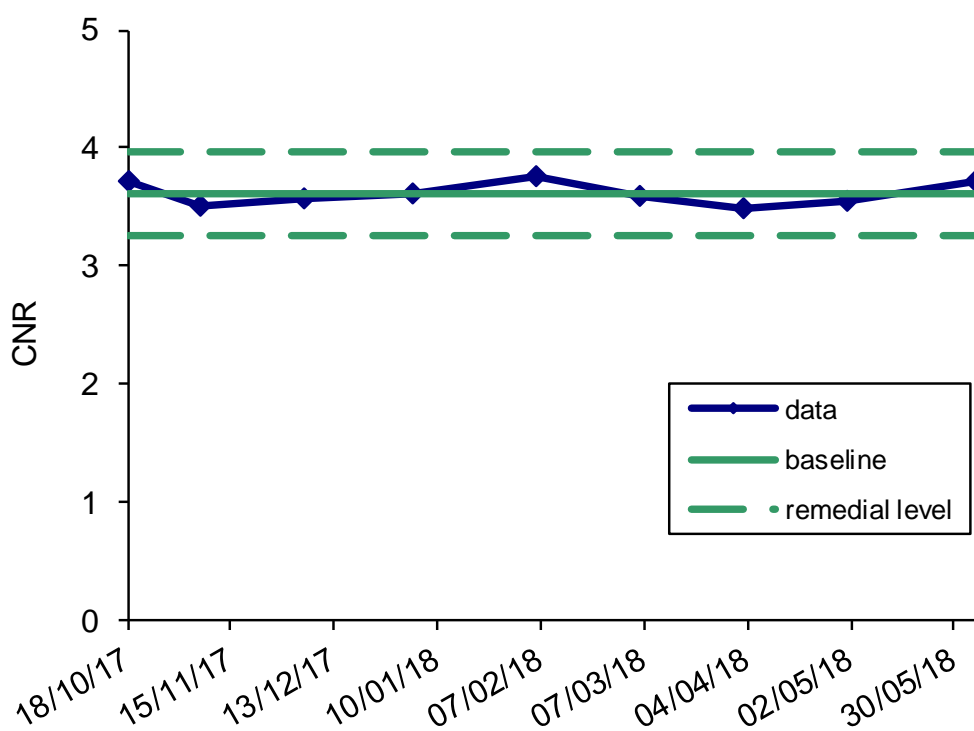
Figure 15. CNR recorded monthly for 70mm of Perspex
