NHS Breast Screening Programme Equipment Report 1602

Practical evaluation of Fujifilm AMULET Innovality digital mammography system

February 2017

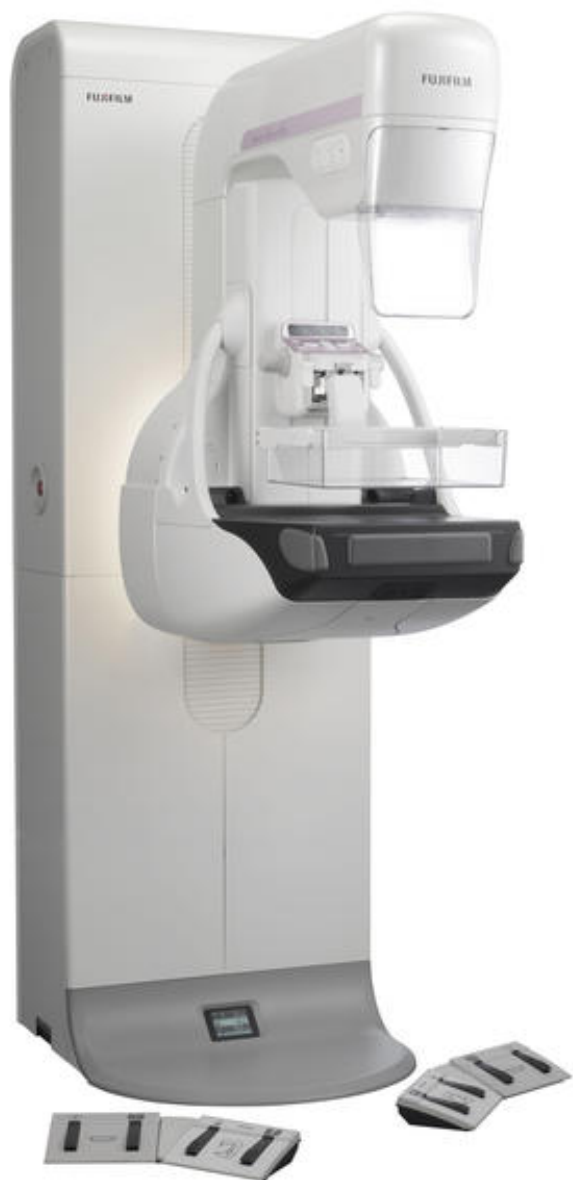
Figure 1. Fujifilm AMULET Innovality X-ray set

The mammography gantry comprises of an automatically controlled C-arm with push button controls on either side. It also has foot pedals to adjust the gantry height and compression plate height. Integrated ambient lighting at the rear of the gantry is intended to help provide a relaxed environment during operation.

Additional operator controls are located on the C-arm, together with a display showing the compression force, compressed thickness and selected angulation. An additional display at the foot of the gantry shows the patient demographics. It changes automatically to show the compression force, compressed breast thickness and selected angulation when the foot controls are operated.

The Innovality is powered by a single phase voltage of 220/240V with a separate generator to the gantry. It has an amorphous selenium detector housed within a moulded carbon fibre casing, utilising optical switching technology. It uses a tungsten target with rhodium and aluminium filters but only rhodium is used for 2D operation.

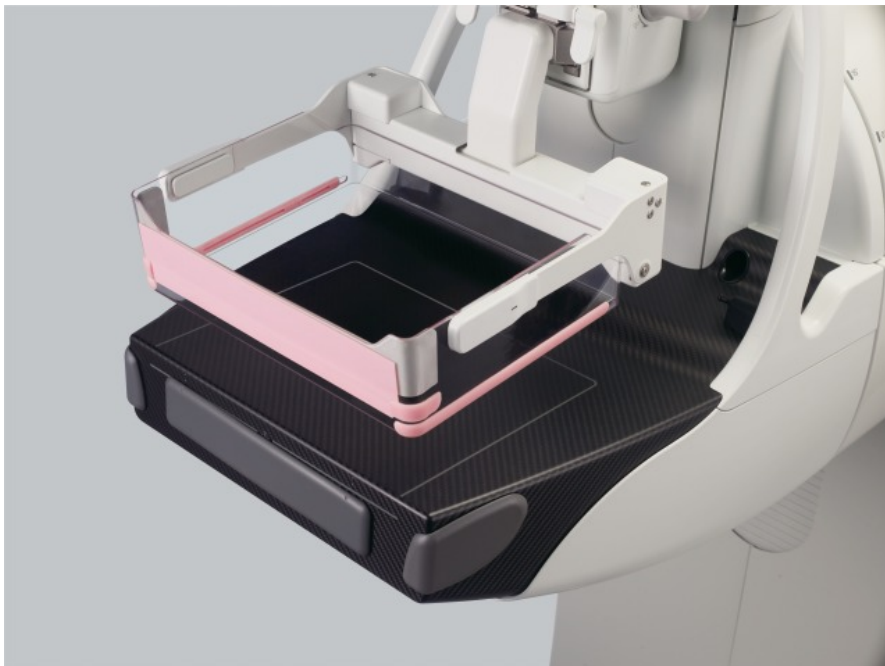
Figure 2. Fit Sweet paddle

The 24cm x 30cm Fit Sweet paddle, shown in Figure 2, was in routine use. This paddle is somewhat flexible and compresses the breast in 2 planes – posterior to anterior

(chest wall to nipple) and lateral to medial aspect. It is designed to maintain good compression while minimising pain.

The Fit Sweet paddle was found to be useful, and seemed to make compression more comfortable for women. Some staff reported difficulty in handling the compression paddles, and in increasing compression slowly enough. Some made suggestions regarding positioning of the control buttons.

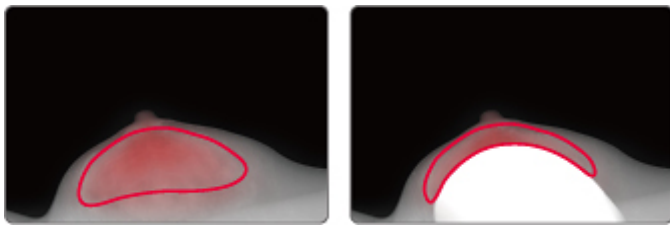
Figure 3. Dense areas selected by iAEC

In iAEC mode the pixel values from the whole pre-exposure image are used to determine the breast area, composition (dense, fatty or implant), and the position of the dense area. These values are used to determine the target/filter combination, tube voltage and mAs. Figure 3 shows the dense tissue identified in unaugmented and augmented breasts. Women with breast augmentation can therefore be imaged in the same manner as for normal breast tissue, without having to select specific parameters.

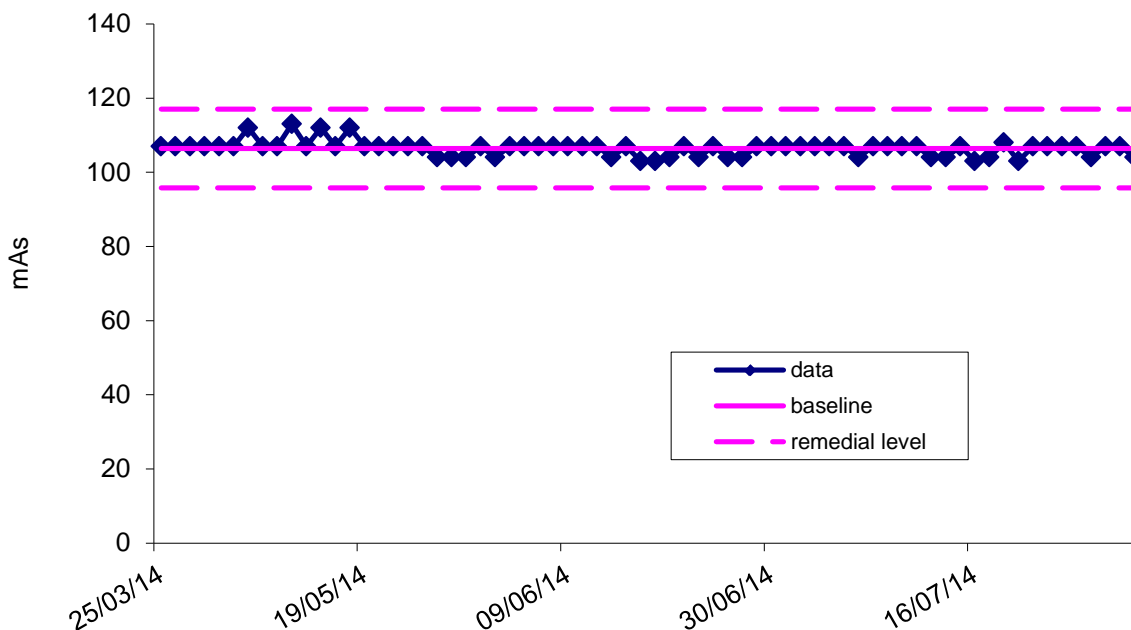
Figure 4. mAs recorded daily for 45mm of Perspex

A 45mm thick block of Perspex was imaged under AEC at the H dose setting. The values for mAs and signal-to-noise ratio (SNR) are shown in Figures 4 and 5. All the values recorded lie within the recommended remedial limits.

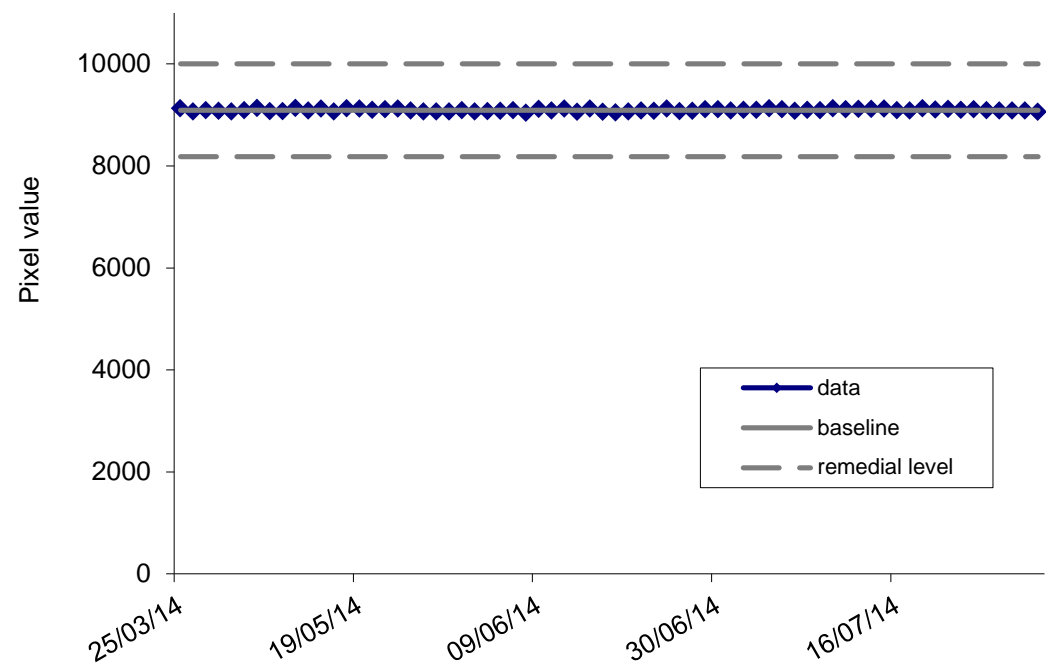
Figure 6. Mean pixel value recorded daily for 45mm of Perspex

Mean pixel values were also recorded on a daily basis. These are shown in Figure 6. The values lie on almost a straight line, indicating that detector response was nearly constant throughout the evaluation period.

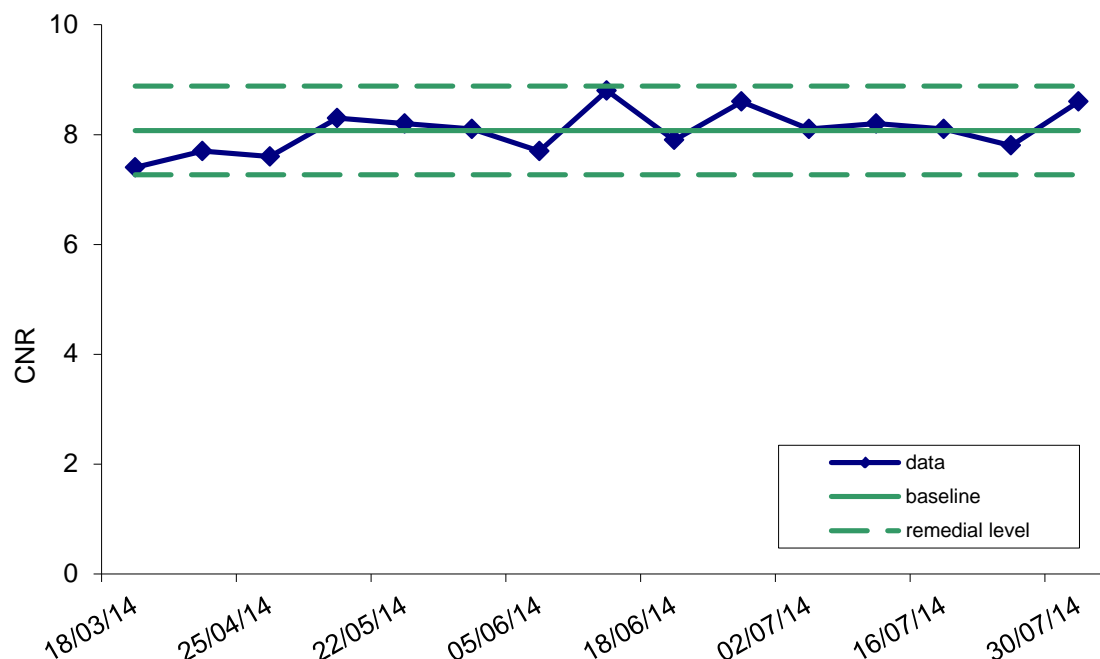
Figure 7. Weekly CNR measurements for 45mm Perspex

In addition to the daily tests, contrast-to-noise ratios (CNR) were recorded weekly. The results are shown in Figure 7. They were within the remedial levels showing that CNR was stable throughout the evaluation. CNR is one indication of image quality.

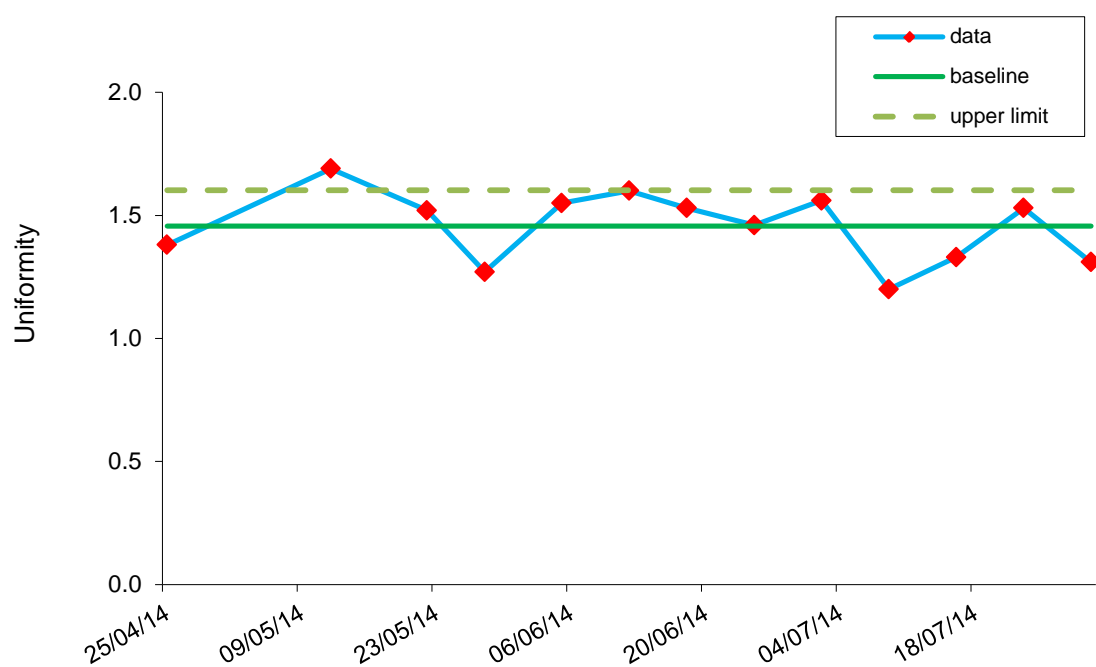
Figure 8. Weekly test of uniformity

Figure 8 shows the results of the weekly uniformity test with some variation throughout the evaluation period, but only one point was just above the upper limit.

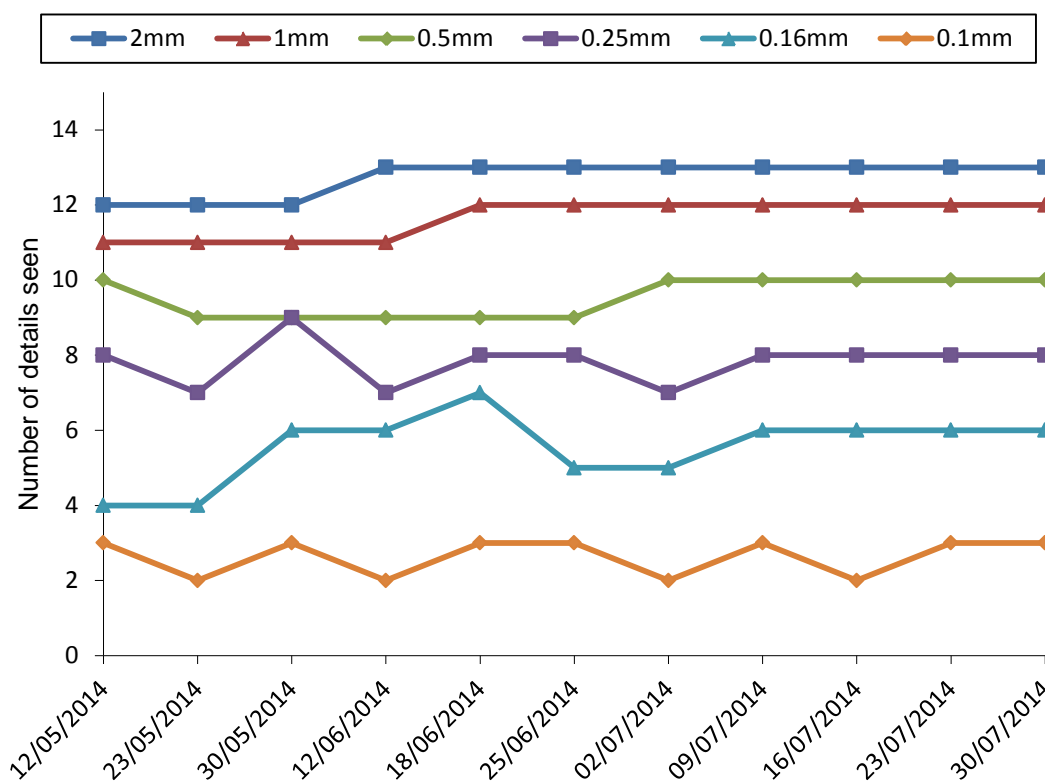
Figure 9. Weekly tests of image quality measured with DMAM test object

The results for image quality measured weekly with a DMAM test object are shown in Figure 9. The figure shows the number of details seen, for a range of detail sizes. There was little variation.

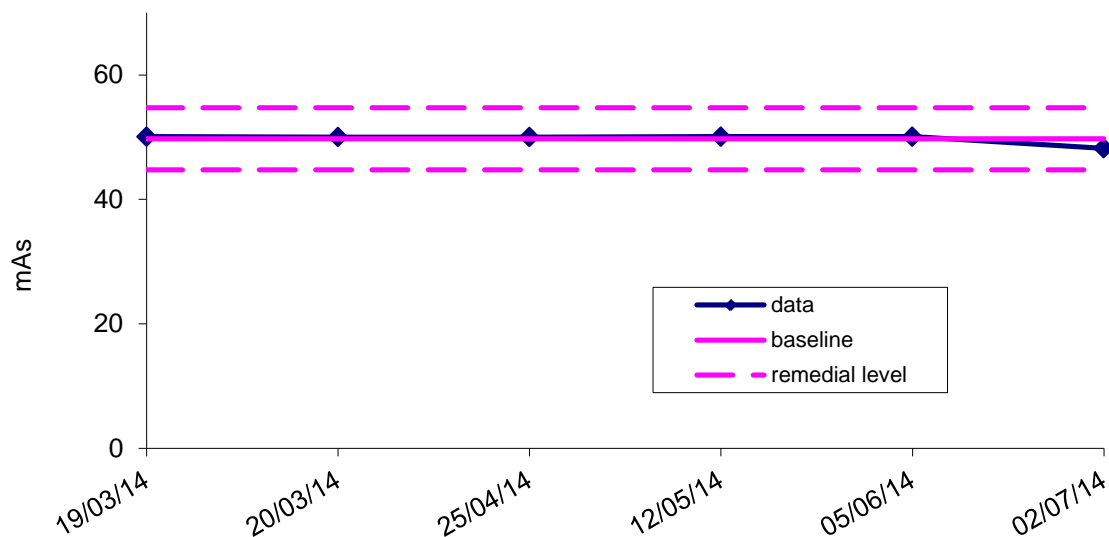
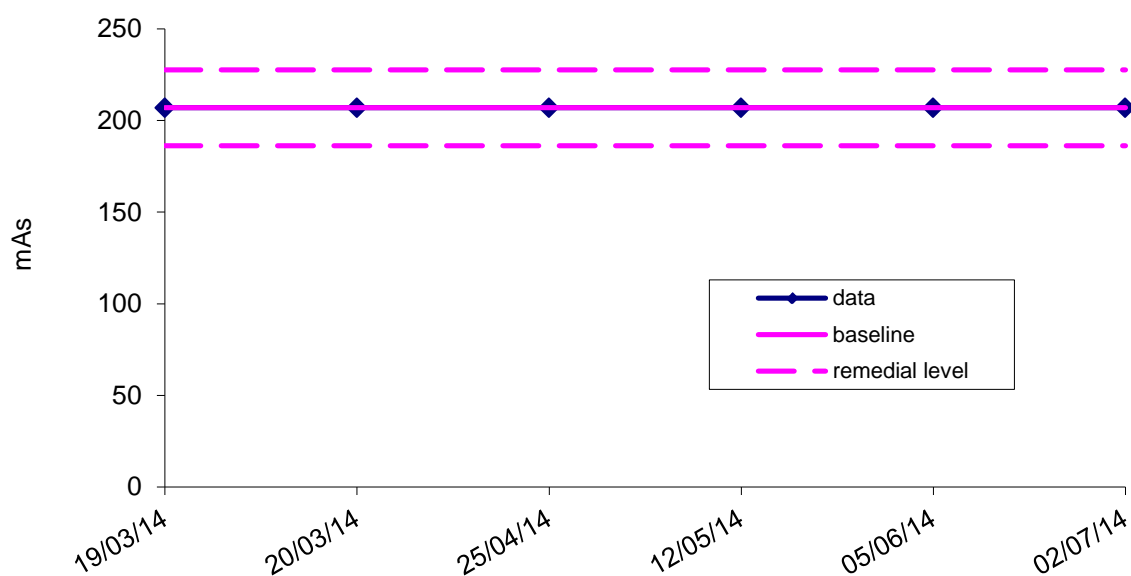
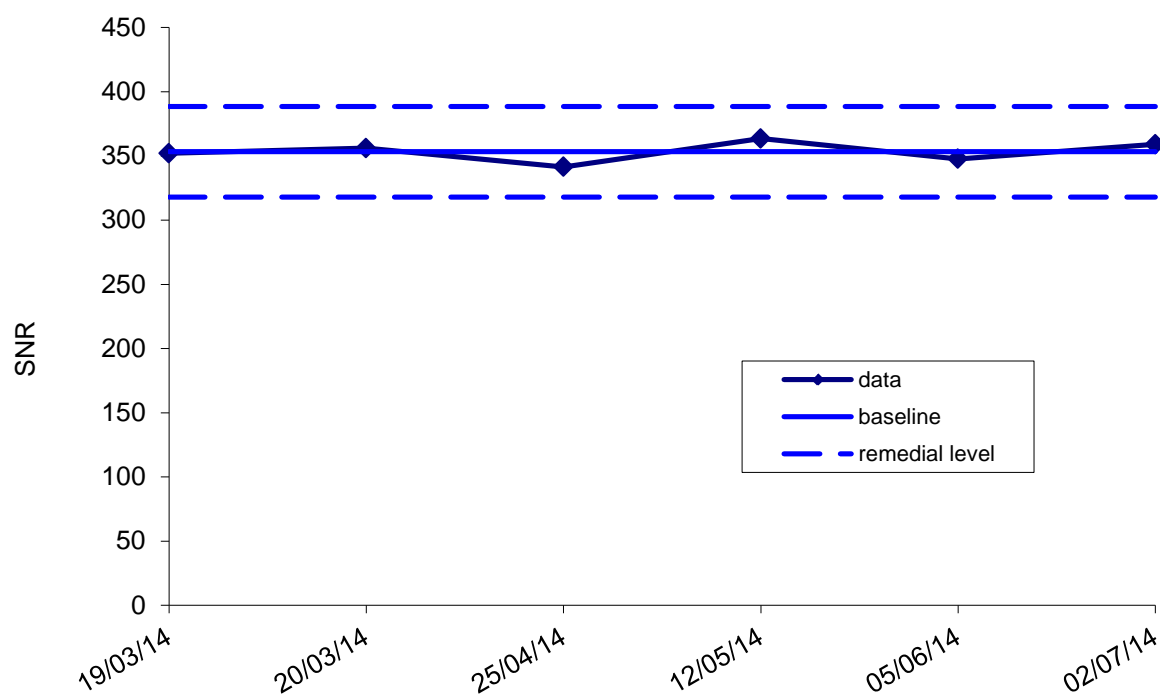
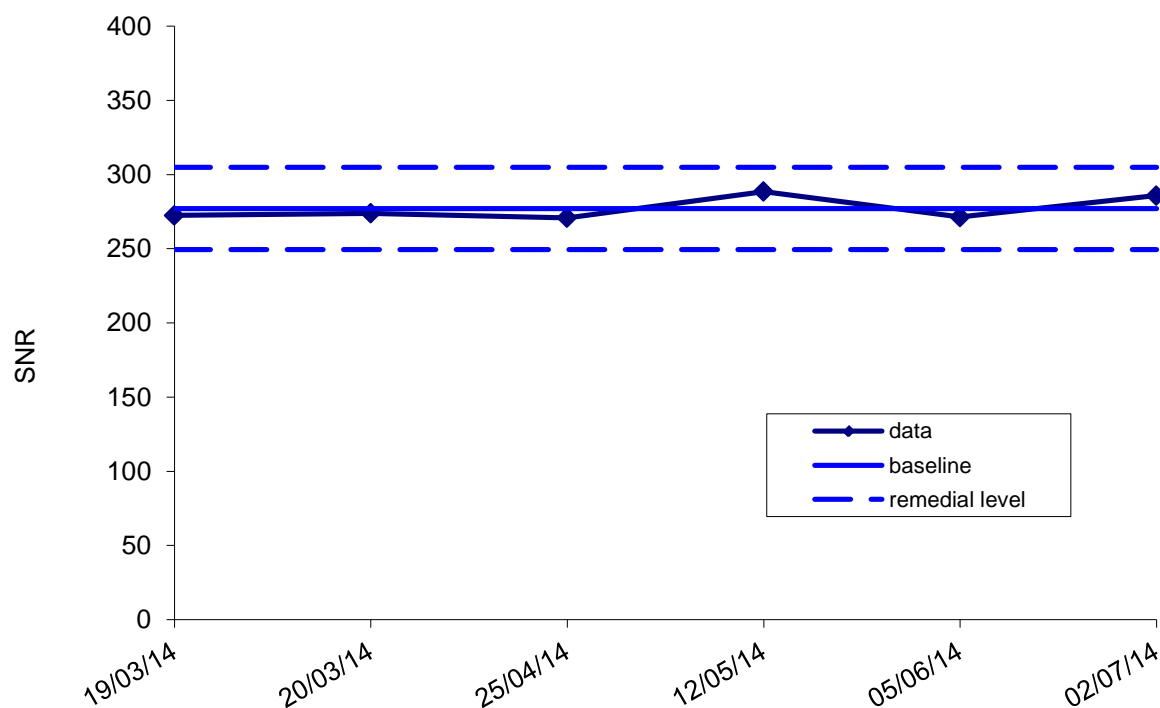
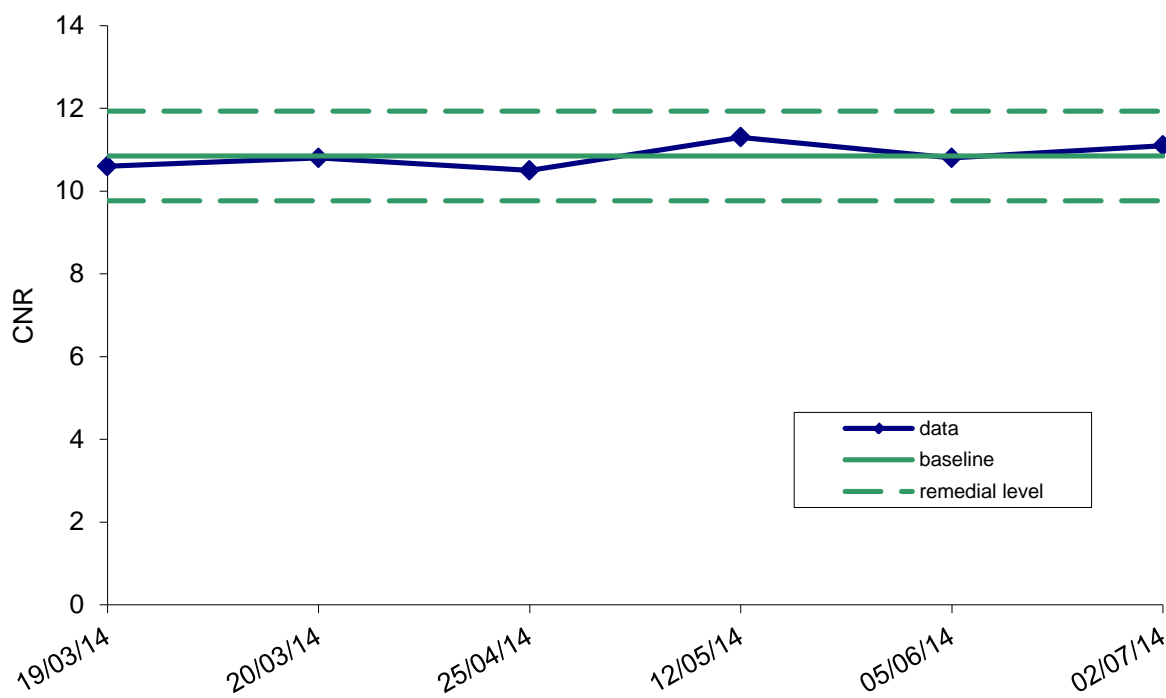
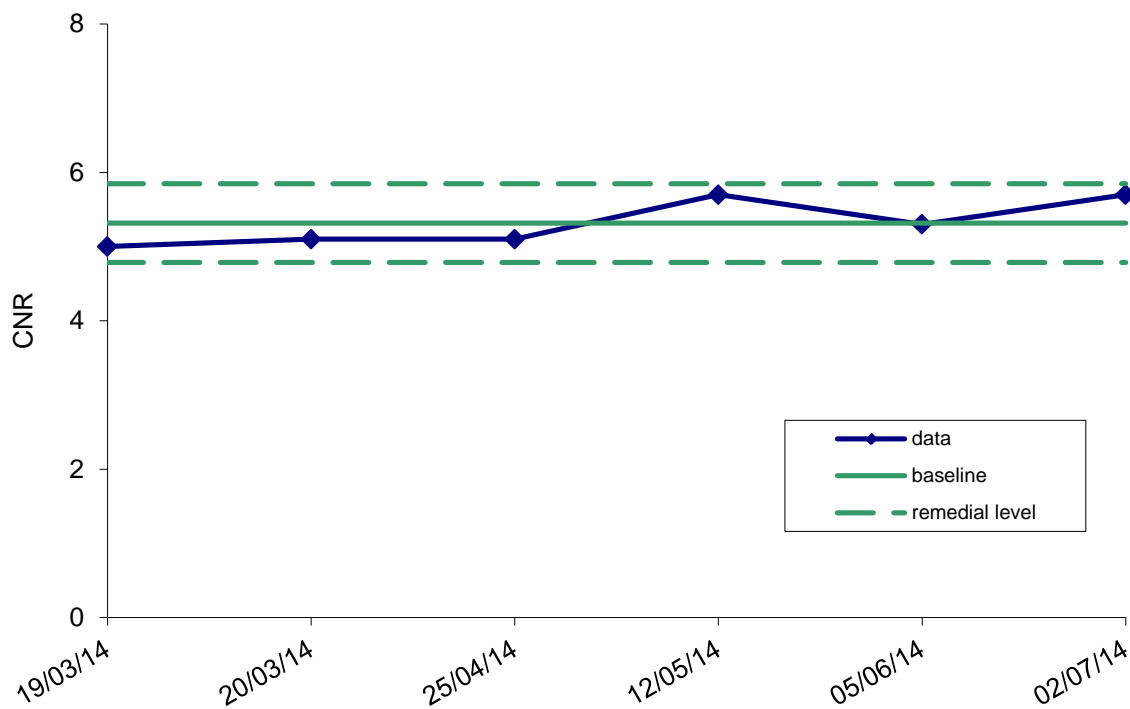
For the monthly tests, Perspex blocks of thickness 20mm and 70mm were exposed under AEC at the H dose setting and the mAs was recorded. The SNR and CNR were also determined for both thicknesses. The results in Figures 10 to 15 show the stability of the system during the evaluation period. All results were within the remedial limits.

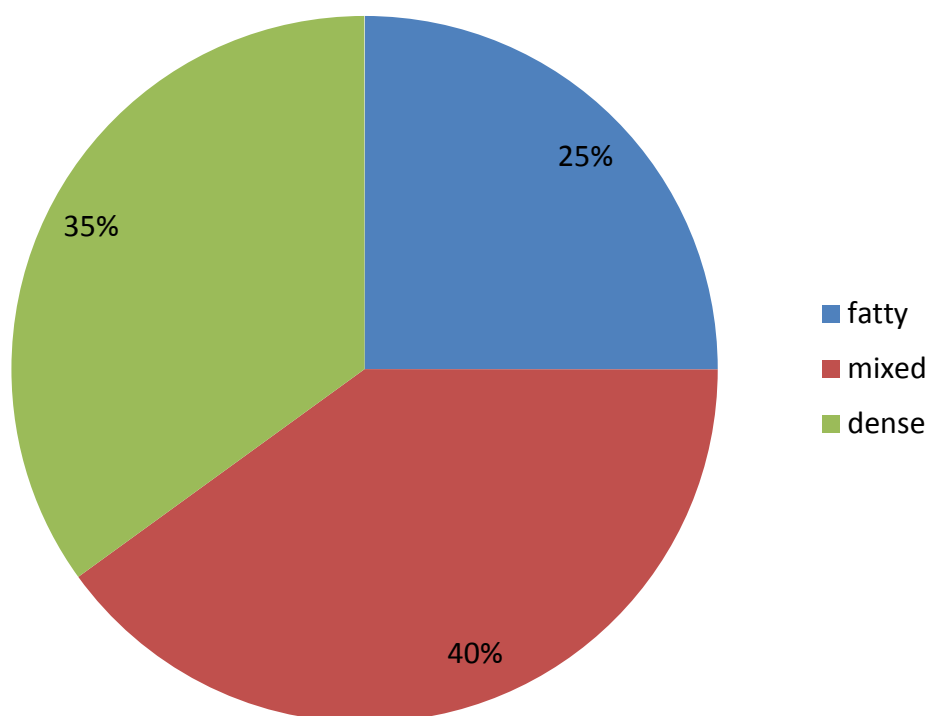
Figure 16. Readers' estimates of breast density

The readers were asked to make an estimate of the percentage of breast density for each case within the dataset collected. These cases were classified as fatty (0-33%), mixed (34-66%) and dense (67-100%). The proportions found in the 20 cases considered were:

- Fatty: 5 cases - 25%
- Mixed: 8 cases - 40%
- Dense: 7 cases - 35%

The results are shown in Figure 16.

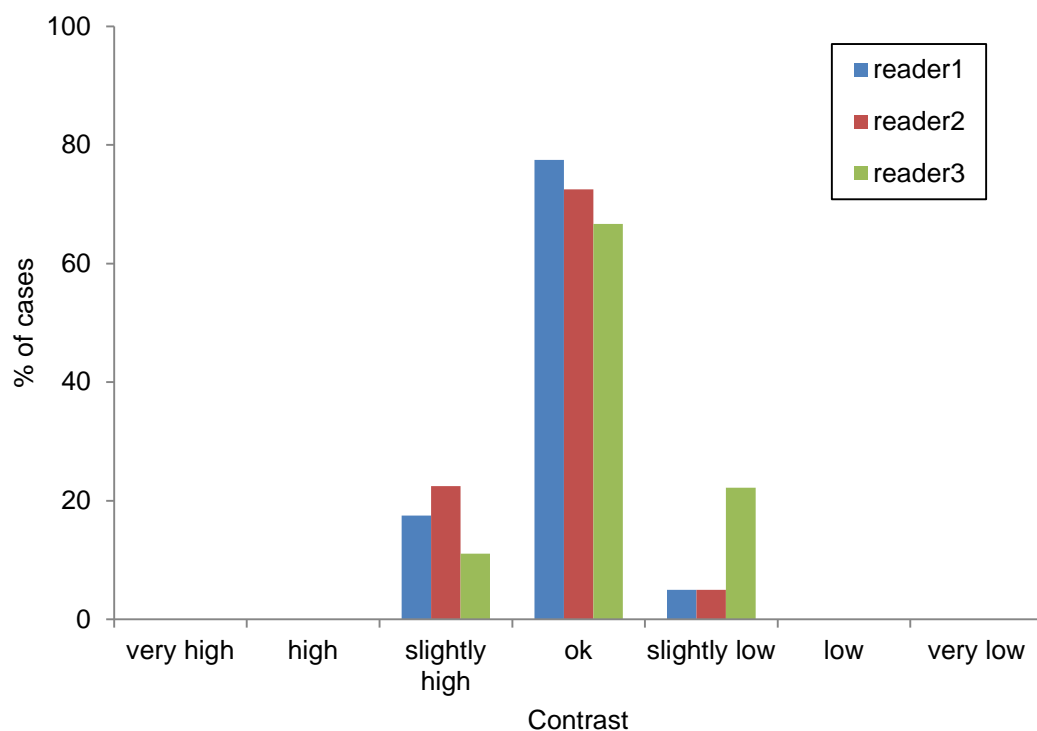
Figure 17. Readers' assessment of contrast

The readers also assessed the contrast for these images. 72% of the cases were rated as satisfactory, with the rest as slightly low contrast or slightly high contrast.

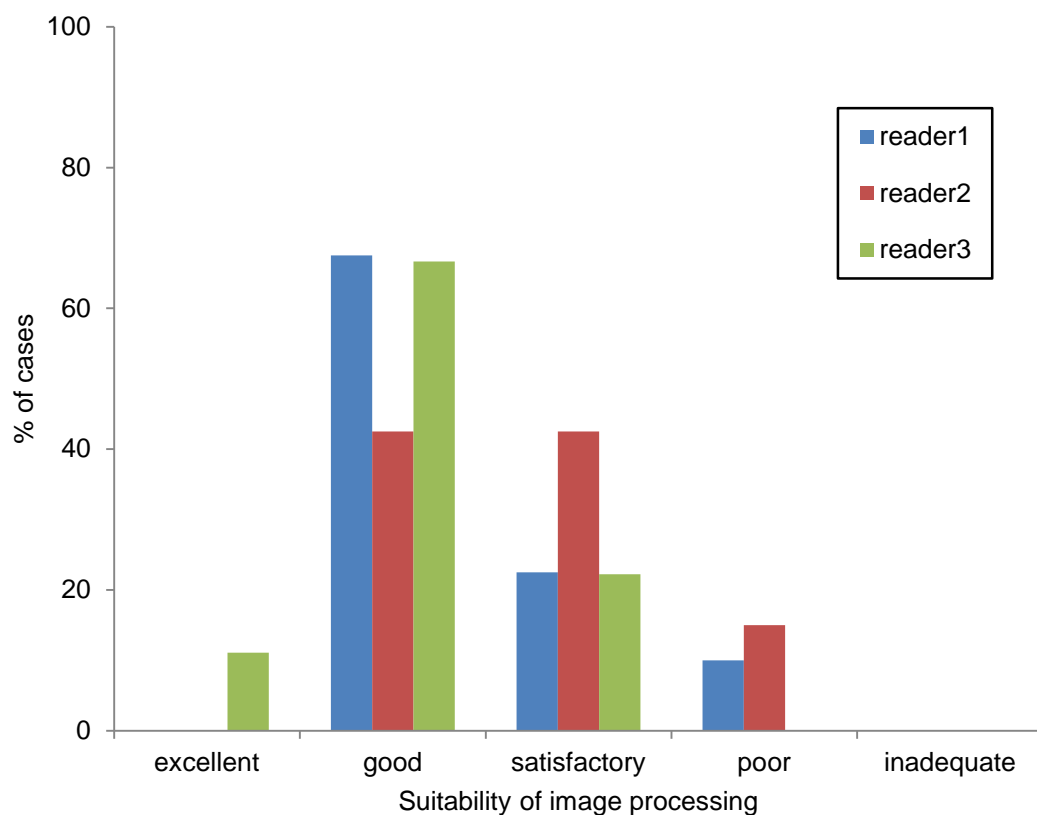
Figure 18. Readers' assessment of suitability of image processing

The results of these assessments are shown in Figures 17 to 20.

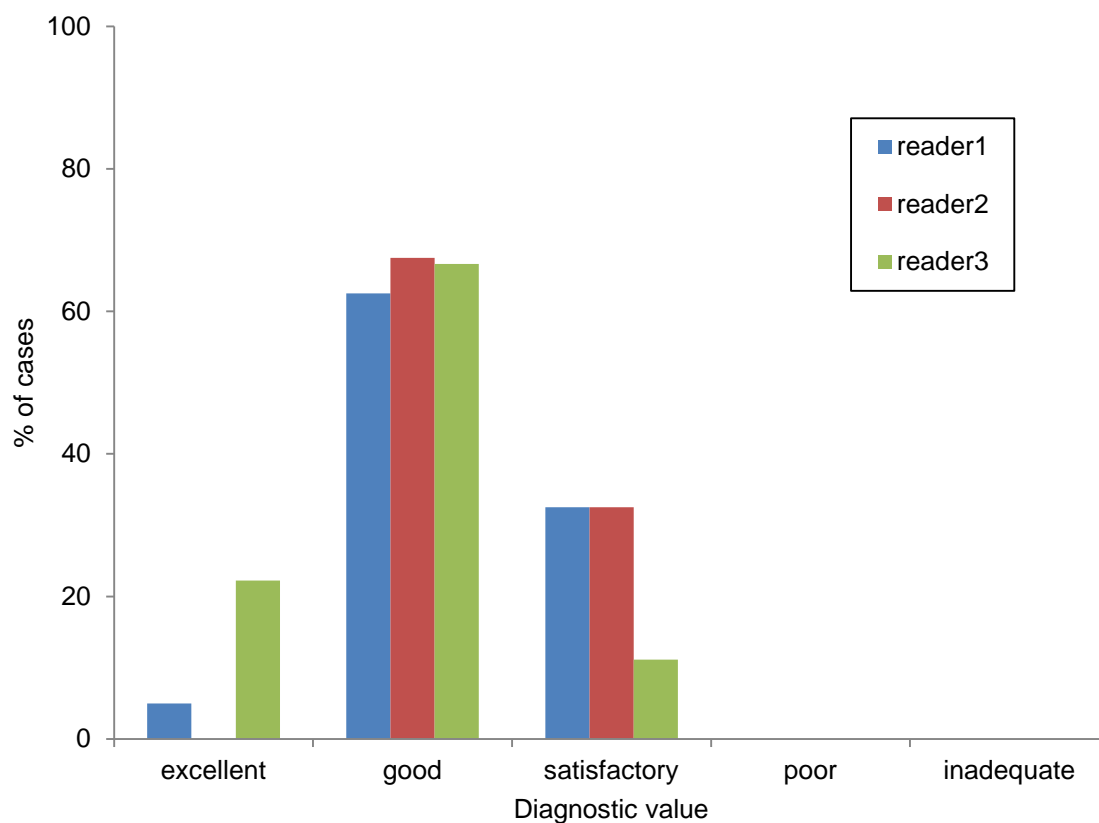
Figure 19. Readers' assessment of overall diagnostic value

Overall diagnostic value was found to be excellent or good in 74% of cases, with the rest satisfactory. No images were assessed as poor or inadequate.

A random sample of 20 sets of images was analysed for this evaluation by the team of readers. Overall, the results were assessed as being good. 74% of the images analysed had an overall diagnostic value of excellent or good, and no images were assessed as poor or inadequate.

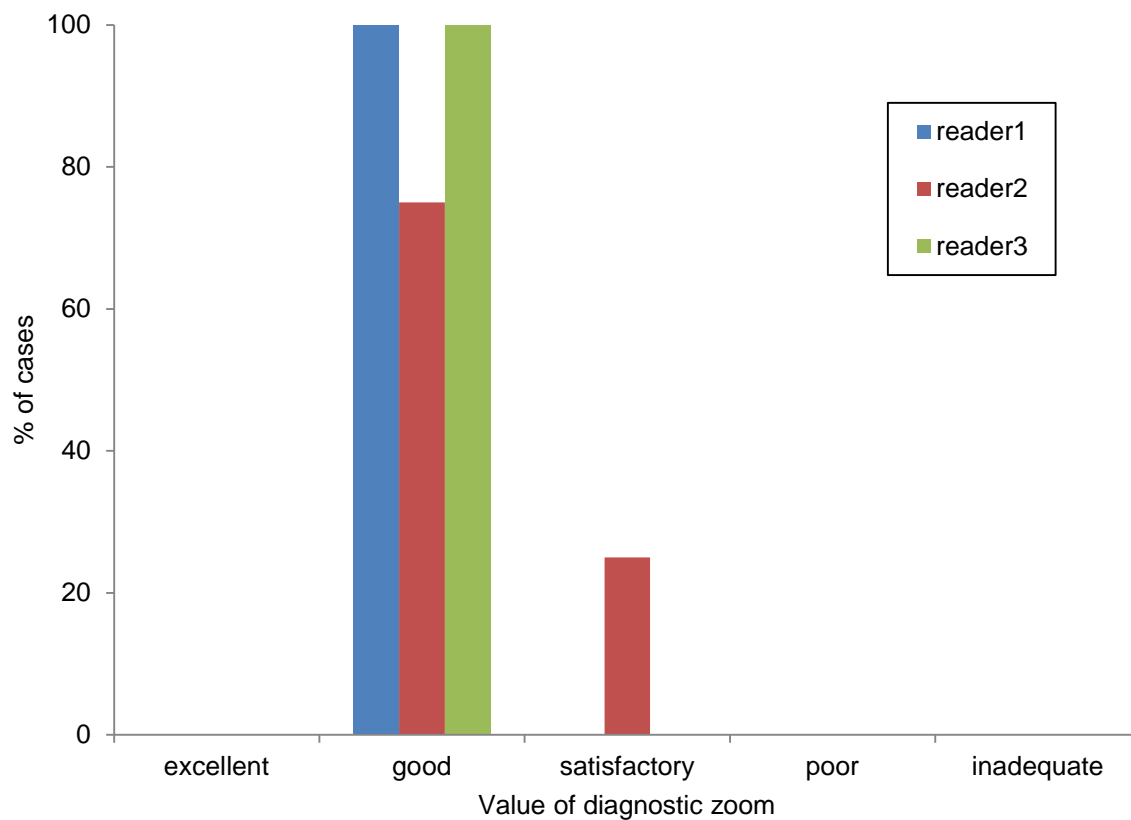
Figure 20. Readers' assessment of diagnostic zoom
